RAPID EVALUATION OF BUILDING SAFETY: LEARNINGS FROM THE DECEMBER 2007 GISBORNE EARTHQUAKE

D R Brunsdon¹

Keynote Presentation delivered at the 2008 Australian Earthquake Engineering Society conference at Ballarat, Victoria.

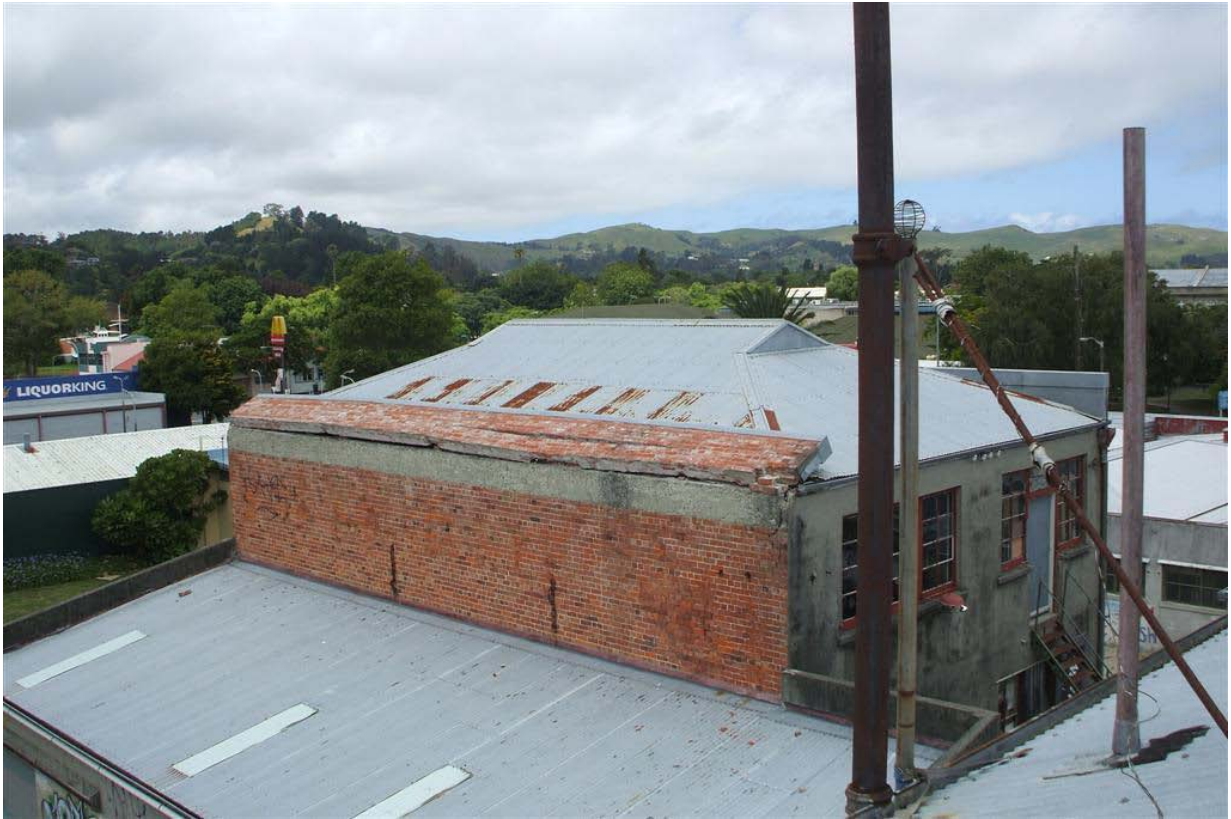
The earthquake was highly directional, being almost exactly parallel to the main street of Gisborne. This meant that unrestrained parapets and walls perpendicular to the main street experienced the greatest out-of-plane accelerations (Figure 3). A common form of damage was therefore from masonry falling from a two storey building onto (and in many cases through) the sheet metal roofing of an adjacent single storey building (Figure 4). Most of the damage in the CBD was directly attributable to damaged or failing parapets.

Figure 3: Indication of common mode of parapet failure parallel to the main street (noting unaffected roof below)

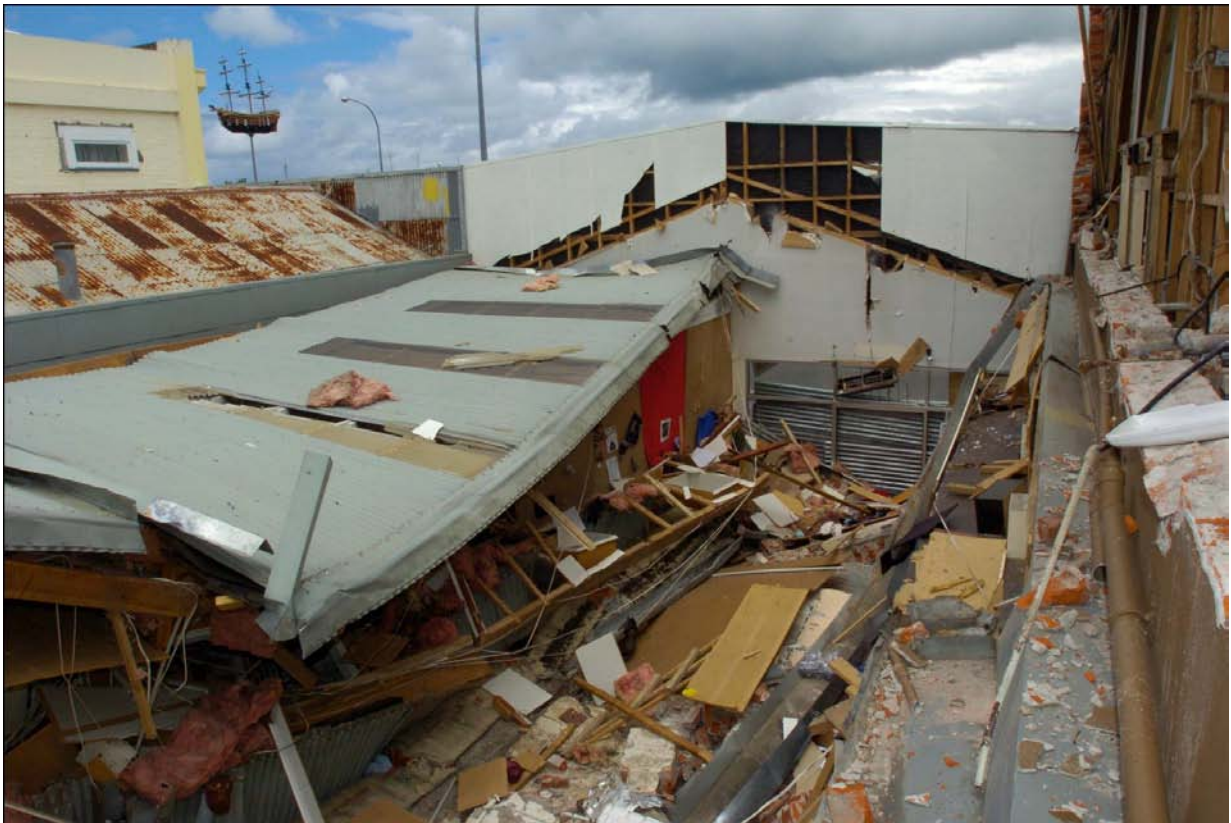
Figure 4: Damage to single-storey building from failure of upper level wall and parapet from neighbouring building at right (Photo from Gisborne Herald)
