**West Coast Lifelines
Vulnerability and Interdependency Assessment**

Supplement 4: Tsunami

West Coast Civil Defence Emergency Management Group

August 2017

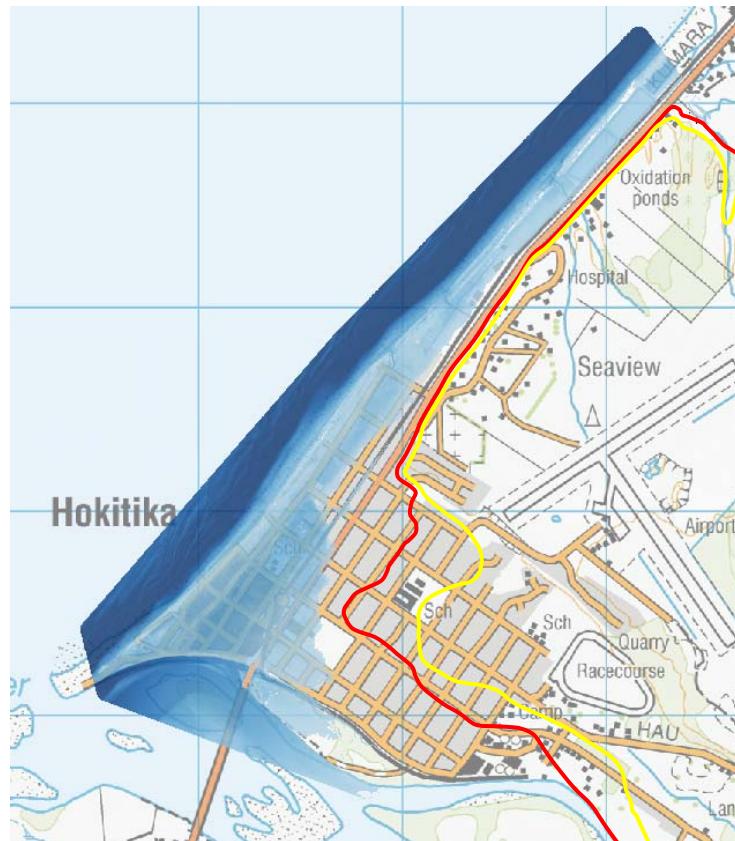
Figure 3.1: Hokitika Inundation

Possible areas of Hokitika inundated with 500 year recurrence interval tsunami (7.2m run-up at shore) No allowance for inundations from the river

See 3.1 for key and limitations

As the ground level in the CBD area is as low as about 2m, inundation depths are likely to be large: 4 – 5m is quite possible in the lower parts of the CBD. Ground levels are about 2m higher at the north end of town, and water depths are likely to be more like 2m. The tsunami wave that affects this degree of flooding will also result in scouring of the beach ridge and the river stopbank. While this will allow more of the flood waters to drain, it also exposes the area to repeated flooding with lower tsunami waves following the largest wave.

The affected part of the town will be subject to:

- Flooding with salt water. Depths will vary from very little at the eastern extremity near the dairy factory to 4 – 5m in the CBD, sufficient to completely fill ground floor spaces and flood second storey spaces.
- Scour of ground on embankments and slopes and around buildings wherever water velocities are high enough.
- Sand and gravel washed from the beach and stopbank redeposited throughout parts of the flooded area.
- Non-fixed items such as vehicles and building contents floating throughout the area and in areas of sufficient velocity causing impact damage to structures.
- Lightweight buildings which are not securely fixed to foundations will be washed away throughout the area west of SH 6. Most timber framed buildings in this area will be destroyed.

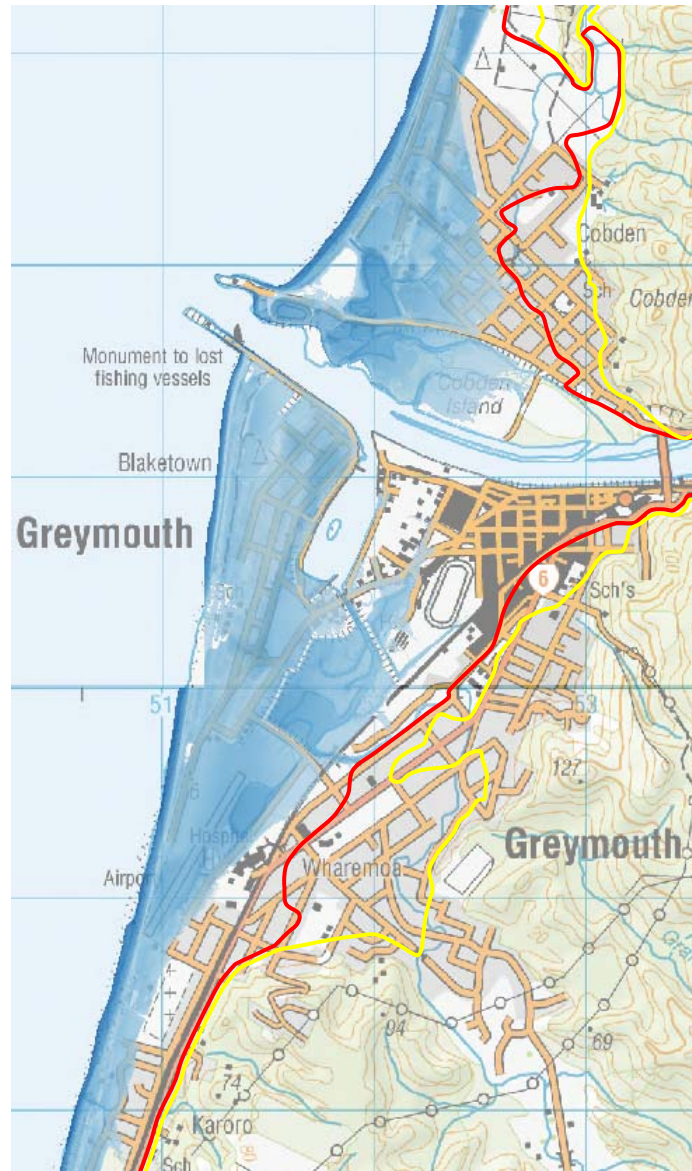
Figure 3.2: Greymouth Inundation

Yellow line is edge of yellow evacuation zone

See 3.1 for key and limitations

The affected part of the town will be subject to:

- Flooding with salt water. Depths will vary from very little at the eastern extremity to 3 - 4m in lower parts of Blaketown.
- Scour of ground on embankments and slopes and around buildings wherever water velocities are high enough.
- Sand and gravel washed from the beach and redeposited throughout parts of the flooded area.
- Non-fixed items such as vehicles and building contents floated throughout the area and in areas of sufficient velocity causing impact damage to structures.
- Lightweight buildings which are not securely fixed to foundations will be washed away throughout the area and many timber framed buildings in the Blaketown area will be destroyed. Structural damage is likely to remaining buildings from water pressure, scour and impact.
- Large amounts of debris will be left throughout the affected area.

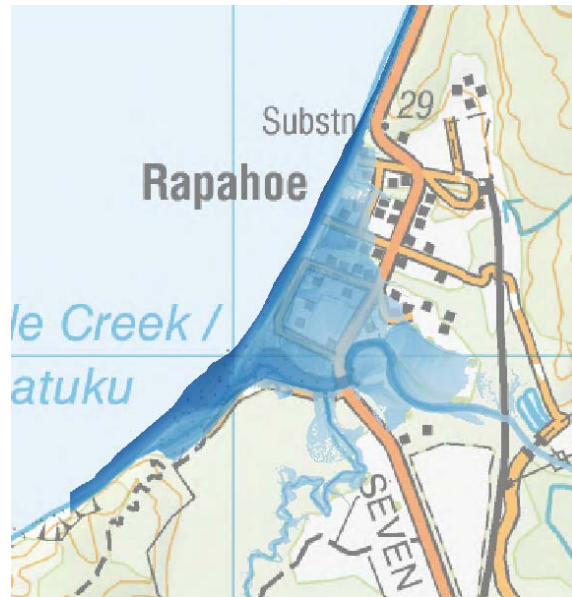
Figure 3.3: Rapahoe Inundation

Possible areas of Rapahoe inundated with 500 year recurrence interval tsunami (7.2m run-up at shore) No allowance for additional inundation from Seven Mile Creek

See 3.1 for key and limitations

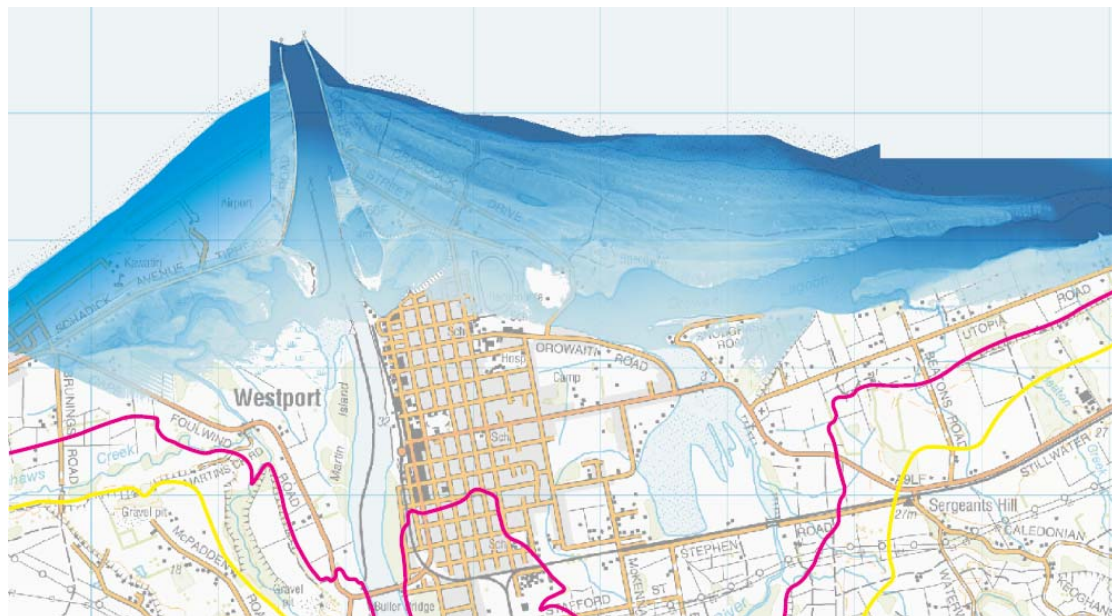
Figure 3.4: Westport Inundation

Possible areas of Westport inundated with 500 year recurrence interval tsunami (9.4m run-up at shore) No allowance for additional inundation from river or Orowaiti estuary. See 3.1 for key and limitations

Westport has been modelled with tsunami coming over the open shoreline only. Westport is exposed on three sides: tsunami overtopping the beach directly at the north end of the town, overflowing from the Buller River on the west and from the Orowaiti estuary on the east, and therefore this inundation area is likely to be under-predicted in at least some areas. Flow patterns are likely to be complex.

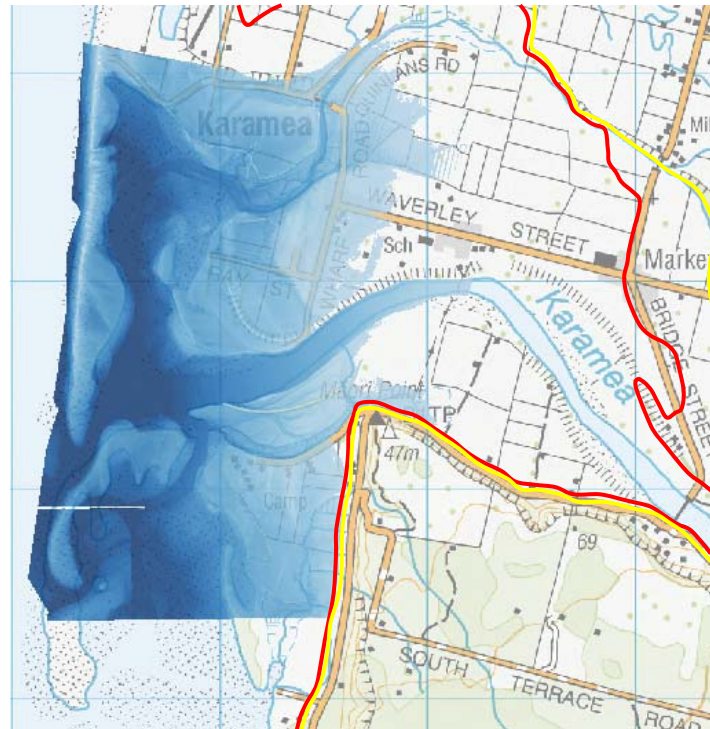
Possible areas of Karamea inundated with 500 year recurrence interval tsunami (7.4m run-up at shore) No allowance for additional inundation from Karamea River

See 3.1 for key and limitations

Beyond the area modelled, the Karamea Highway between Little Wanganui and Karamea runs for 11km at between 0.1 and 0.5km of the shore, and most of this length can be expected to be inundated. The substation part way along this length at Kongahu is about 0.4km inland and is also likely to be within the inundation zone, as is the main power line to the district.
